CONDITION
REPORT

EXAMPLE BULK CARRIER

IMO Number: 123456789

1st MAY 2023

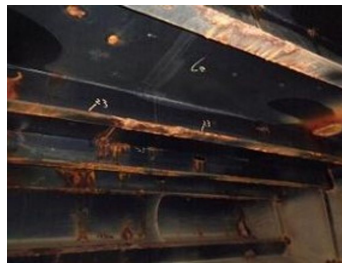
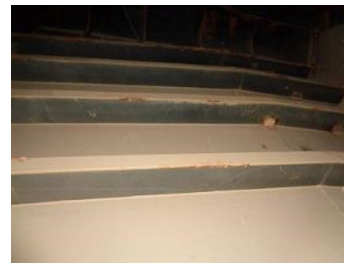
Ballast tanks and systems were deemed to be in a fair to good overall condition. No tanks could be entered due to not prepared for safe entry however, photographs of previous tank entries in 13-Mar-23 were provided for review. From the photographs provided, it was seen that the ballast tanks were found to be generally free of significant structural defects and had only minor scattered and scaling corrosion, up to approximately 5% of the ballast tanks total surface area, mainly located across

frame edges. Ballast tank fittings such as ladders and pipework were seen to be in a good overall condition with Anodes seen to be depleted up to 5%. Tanks were seen to have a minimal amount of mud/sediment accumulation but were free of any signs of staining from sewage or marine fouling. Ballast control systems such as valves and gauges were reported to be fully operational and all ballast pumps were in good working order and in good visual condition.

Issue: Ballast tanks noted with developing corrosion to frame edges.

Corrective Action: Crew maintenance required.
