PRE-PURCHASE
INSPECTION

EXAMPLE BULK CARRIER

INSPECTED AT EXAMPLE PORT, TURKEY

1st MAY 2023

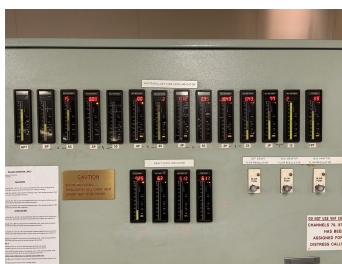
Issue: Several ballast tank remote gauge indicators, from tanks 3 port and starboard, 4 port, and 5 port and starboard, were noted to be out of order.

Corrective Action: To be further investigated and rectified as soon as practical.

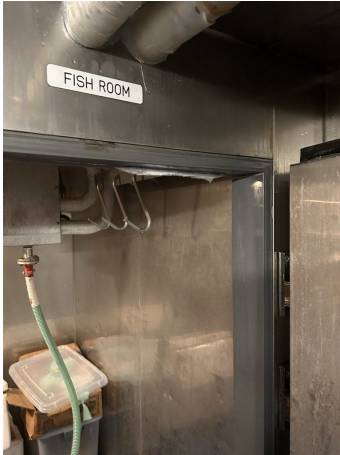
Issue: Provisions equipment was seen with excess frosting with minor ice accumulation noted on the upper corner of fish room inner door frame, as well as to sections of the external pipework.

Corrective Action: De-frost and rectify root cause of excess ice build-up.

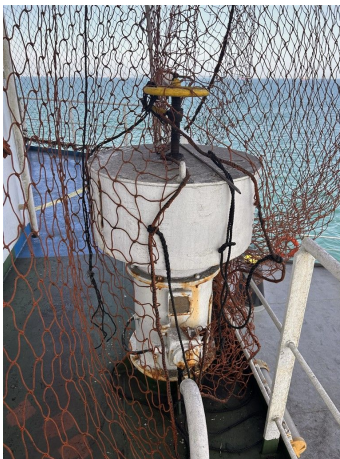
Issue: The paint store fan damper was seen to be covered with nets that obstructed the access and operation, as well as missing open/close markings sighted on the ventilation dampers on poop deck.

Corrective Action: To be further investigated and rectified as soon as practical.

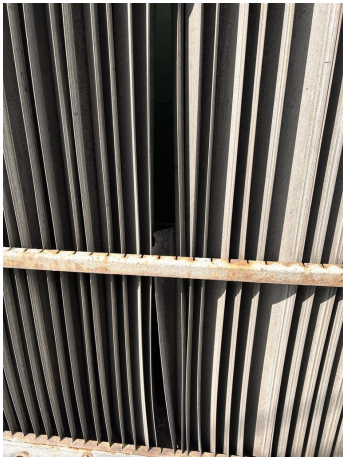
Issue: Several ventilation louvers of engine room port and starboard side fans were found to be broken.

Corrective Action: To be further investigated and rectified as required.
