PRE-PURCHASE
INSPECTION

EXAMPLE TANKER

IMO Number: 123456789

1st MAY 2023

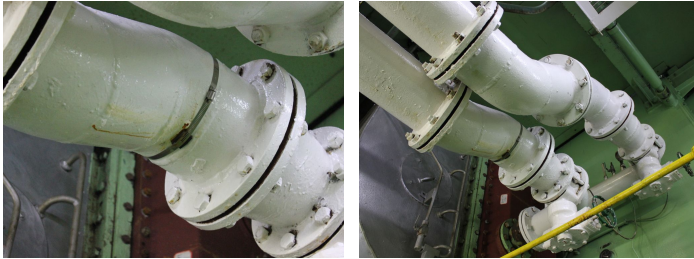
Issue: Main engine air cooler pipe noted with a temporary repair.

☒ No*Main engine air cooler pipe noted with a temporary patch*

Corrective Action: Renew areas of pipework that have temporary repairs.
