Example Bulk Carrier

INSPECTED AT EXAMPLE PORT UNITED STATES 1st MAY 2023

INSPECTION SUMMARY

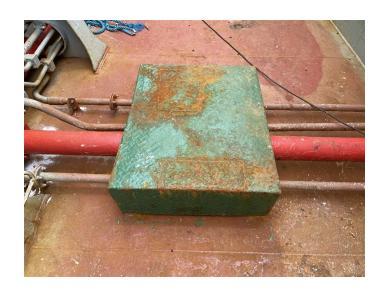
Description	Estimated Cost [USD]
Issue: Developing corrosion seen over the edges of most fittings on the weather decks and corrosion was seen over some localised areas of the decks. Corrosion and paint breakdown was seen on ventilation heads, pipeline supports, pipework U-bolts, bulwarks and sounding pipes. Developing corrosion was also seen on the checker plate cross over steps, mechanical vent heads and hatchways and weather tight openings.	\$5000 - \$20000
Corrective Action: Routine maintenance to be considered to arrest further deterioration,.

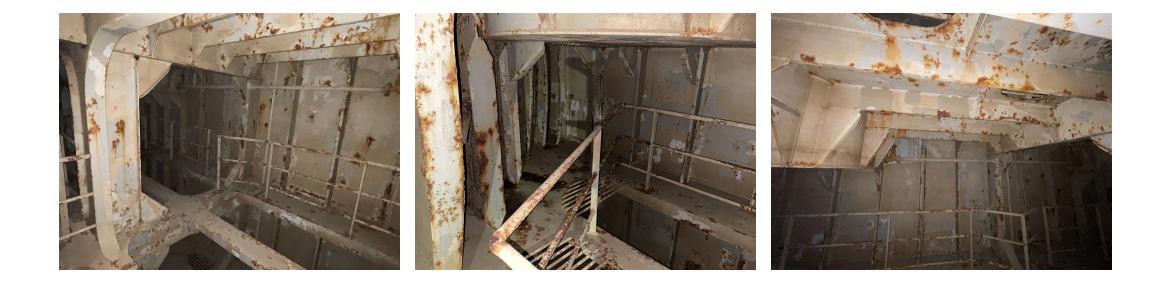
Issue: Developing corrosion seen over the stringer plates and longitudinal edges in the F.P.T. **Corrective Action:** Routine maintenance to be considered to arrest further deterioration.
