EXAMPLE LNG CARRIER

IMO Number: 123456789

INSPECTED AT EXAMPLE PORT, UNITED ARAB EMIRATES 1st MAY 2023

INSPECTION SUMMARY

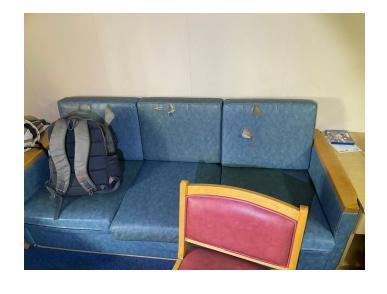
Description	Estimated Cost [USD]
Issue: Crew recreation room furniture upholstery was torn and deteriorated. Corrective Action: It is recommended that the affected furnishings are refurbished at the earliest conveneince.	\$1000 - \$5000

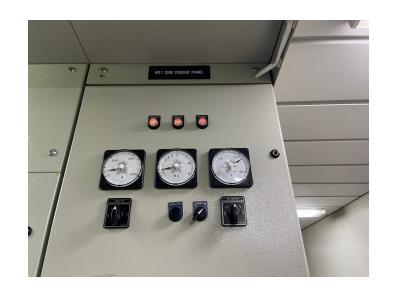
•	The main switchboard was seen to have low insulation readings with Main Switch Board 220 V distribution has low insulation Megohm	Investigate and rectify cause of the low insulation as soon as possible.	\$0

Estimated
Description	Cost
	[USD]
Issue: The main switchboard was seen to have low insulation readings with Main Switch Board 220 V distribution has low insulation Megohm	† 0
Corrective Action: Investigate and rectify cause of the low insulation as soon as possible.	\$0
