Example Bulk Carrier

INSPECTED AT EXAMPLE PORT UNITED STATES 1st MAY 2023

INSPECTION SUMMARY

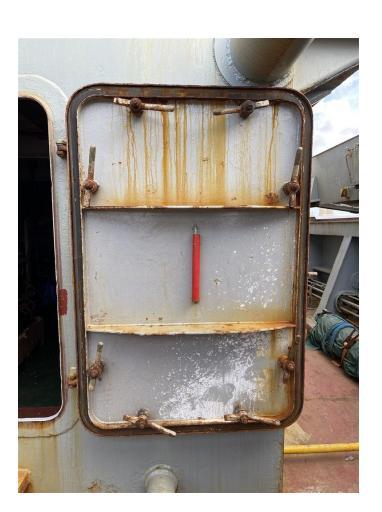
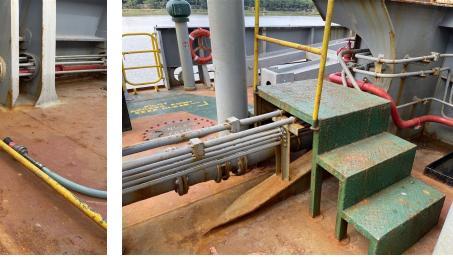
Description	Estimated Cost [USD]
Issue: Developing corrosion seen over the edges of most fittings on the weather decks and corrosion was seen over some localised areas of the decks. Corrosion and paint breakdown was seen on ventilation heads, pipeline supports, pipework U-bolts, bulwarks and sounding pipes. Developing corrosion was also seen on the checker plate cross over steps, mechanical vent heads and hatchways and weather tight openings.	\$5000 - \$20000
Corrective Action: Routine maintenance to be considered to arrest further deterioration,.
