PRE-PURCHASE  
INSPECTION

## EXAMPLE VESSEL

IMO Number: 123456789

INSPECTED AT EXAMPLE PORT, SPAIN

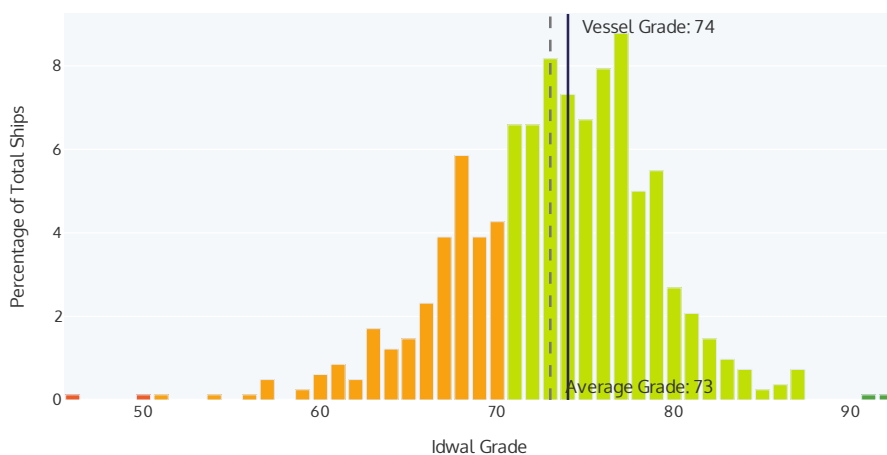
## Your Idwal Grade vs other Feeder Container vessels

This graph shows the distribution of Idwal Grades against your ship's sector.

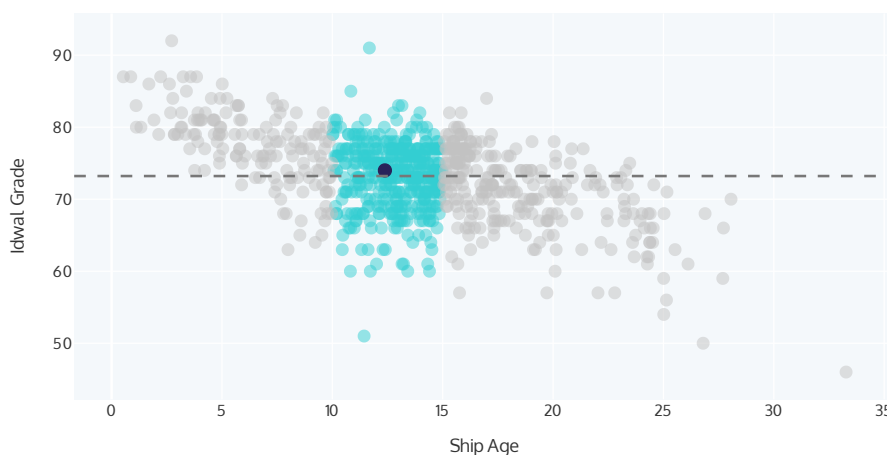
## Your Idwal Grade vs other Feeder Container vessels, age 10-15 years

This graph shows your ship's Idwal Grade compared against other ships inspected in the same sector, within a similar age range, and how it compares against the average Idwal Grade for the sector.
