PRE-SALE REPORT

EXAMPLE GENERAL CARGO

INSPECTED AT DURBAN SOUTH AFRICA

1st MAY 2023

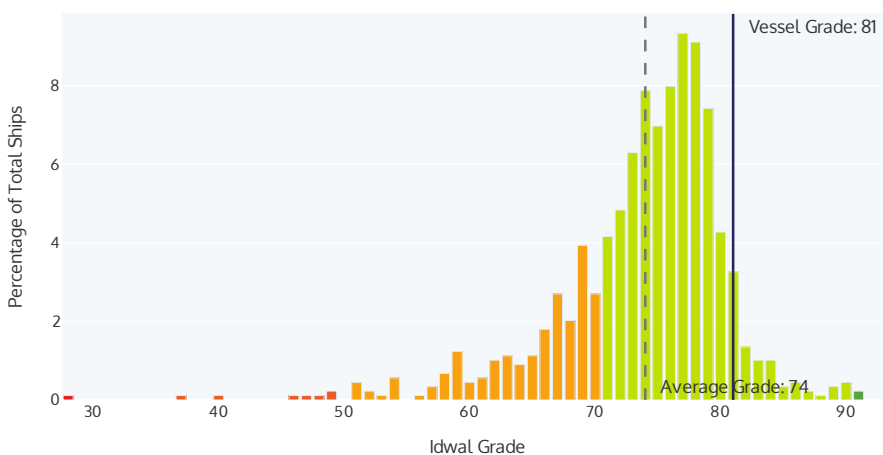
Your Idwal Grade vs other General Cargo vessels

This graph shows the distribution of Idwal Grades against your ship's sector.
