PRE-PURCHASE
INSPECTION

EXAMPLE LPG CARRIER

INSPECTED AT EXAMPLE PORT, EXAMPLE COUNTRY
1st MAY 2023

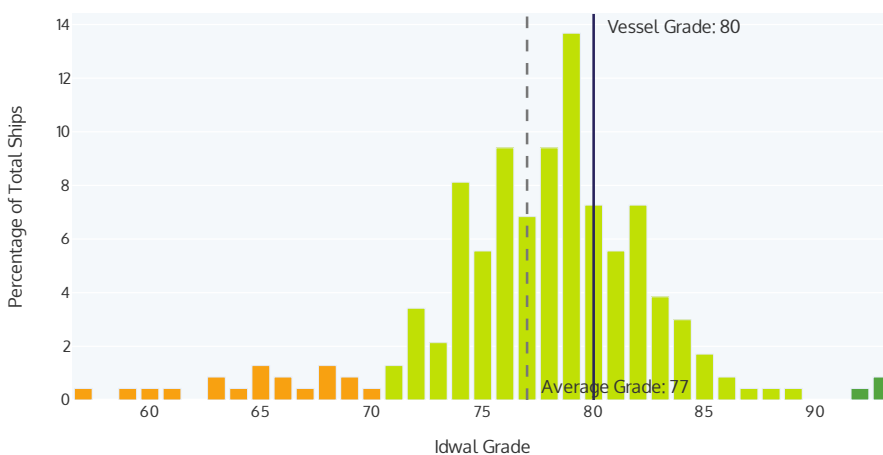
Your Idwal Grade vs other LPG Tanker vessels

This graph shows the distribution of Idwal Grades against your ship's sector.

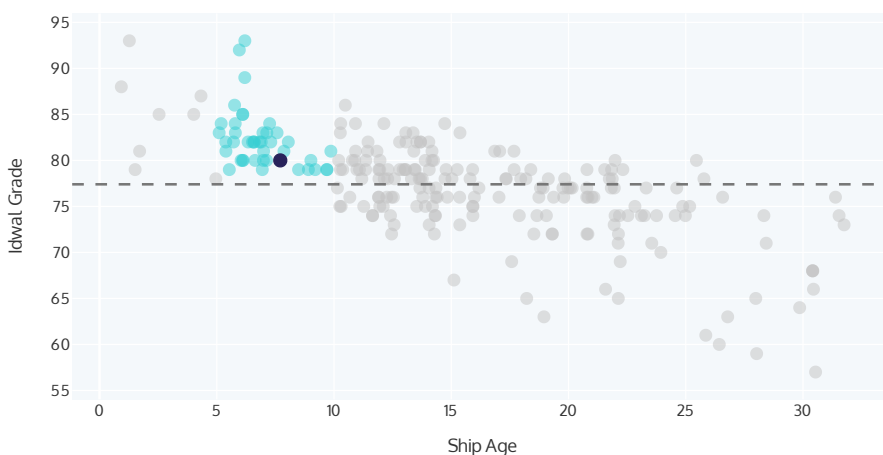
Your Idwal Grade vs other LPG Tanker vessels, age 5-10 years

This graph shows your ship's Idwal Grade compared against other ships inspected in the same sector, within a similar age range, and how it compares against the average Idwal Grade for the sector.
