PRE-SALE
REPORT

EXAMPLE CHEMICAL TANKER

IMO Number: 123456789

INSPECTED AT EXAMPLE PORT, MALAYSIA

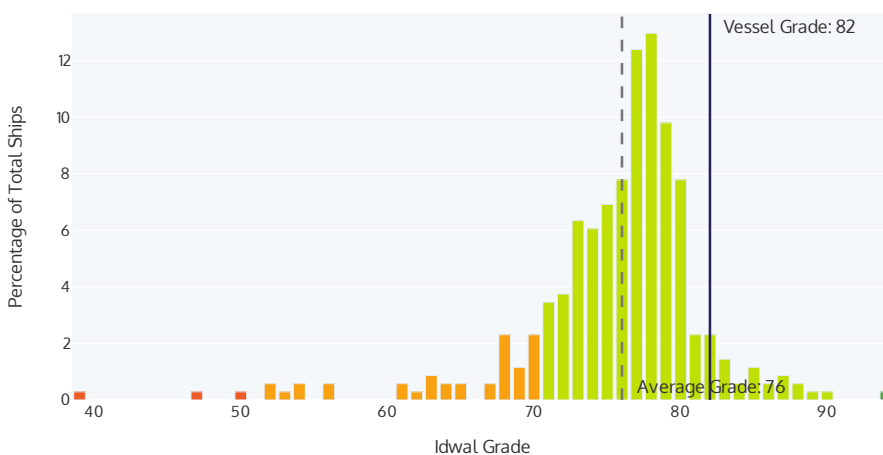
Your Idwal Grade vs other SR Tanker vessels

This graph shows the distribution of Idwal Grades against your ship's sector.

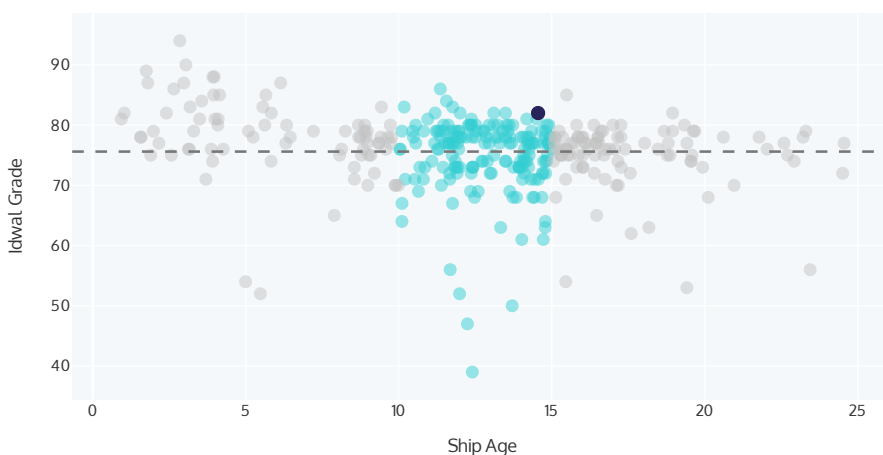
Your Idwal Grade vs other SR Tanker vessels, age 10-15 years

This graph shows your ship's Idwal Grade compared against other ships inspected in the same sector, within a similar age range, and how it compares against the average Idwal Grade for the sector.
